IRMRC Research Report

MOTORCYCLE CRASHES INTO ROADSIDE BARRIERS STAGE 1: CRASH CHARACTERISTICS AND CAUSAL FACTORS

NSW Injury Risk Management Research Centre
(IRMRC)

March 2010

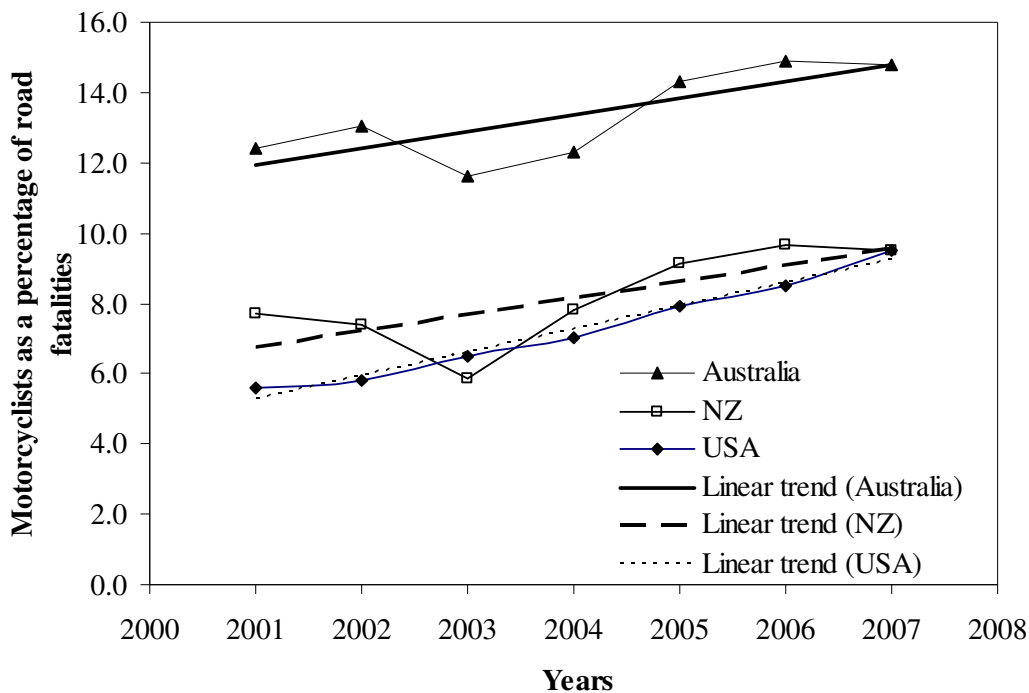
Figure 1: Motorcyclists as a percentage of all road fatalities in Australia, NZ and the USA
(Data sources: Australian Bureau of Statistics, NZ Crash Analysis System and US Fatality Analysis and Reporting System)

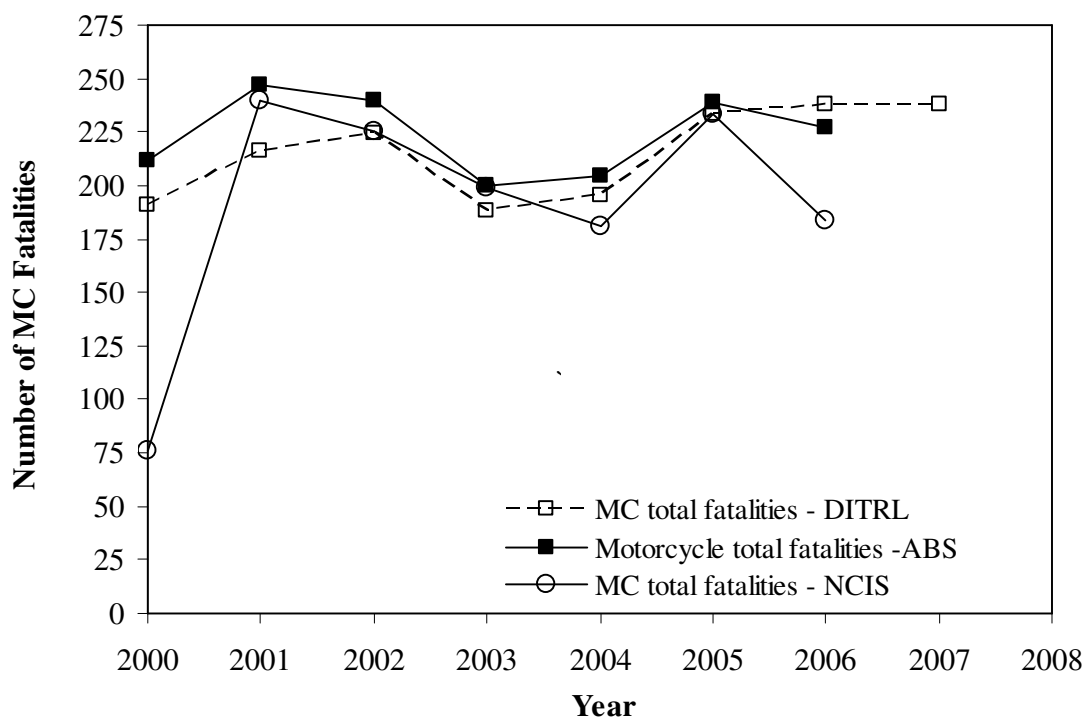
Figure 2: Comparison of fatal motorcycle crashes in Australian jurisdictions from various sources (2000 to 2007)

To gauge the reliability of the Australian data, the annual motorcycle deaths identified from the NCIS was compared to the motorcycle deaths recorded by the Australian Department of Infrastructure, Transport, Regional Development and Local Government (DITRL) and the Australian Bureau of Statistics (ABS). Figure 2 shows that the data extracted from the NCIS, DITRL and ABS were generally in agreement. However, the data from ABS consistently reported a slightly higher number of deaths than that from NCIS or DITRL. The NCIS data for 2000 and 2006 appear to stand out as being least consistent with the other databases. The NCIS began operations in June 2000 and the state of Queensland joined in January 2001, therefore the data in 2000 are incomplete. At the time the search was conducted, there were many 2006 cases still open resulting in the lower NCIS totals.

In addition to the difficulties associated with the NCIS data for the years 2000 and 2006, there are a number of reasons why motorcycle fatality numbers differ between data sources. These include issues such as coding errors, missing data and variations in the definition of a road fatality. For example, ABS data refer to underlying cause of death which may include a long period of complicating illnesses as a result of injury sustained in a motorcycle crash. Nevertheless, the data from all sources are in reasonably close agreement for the years 2001 to 2006.

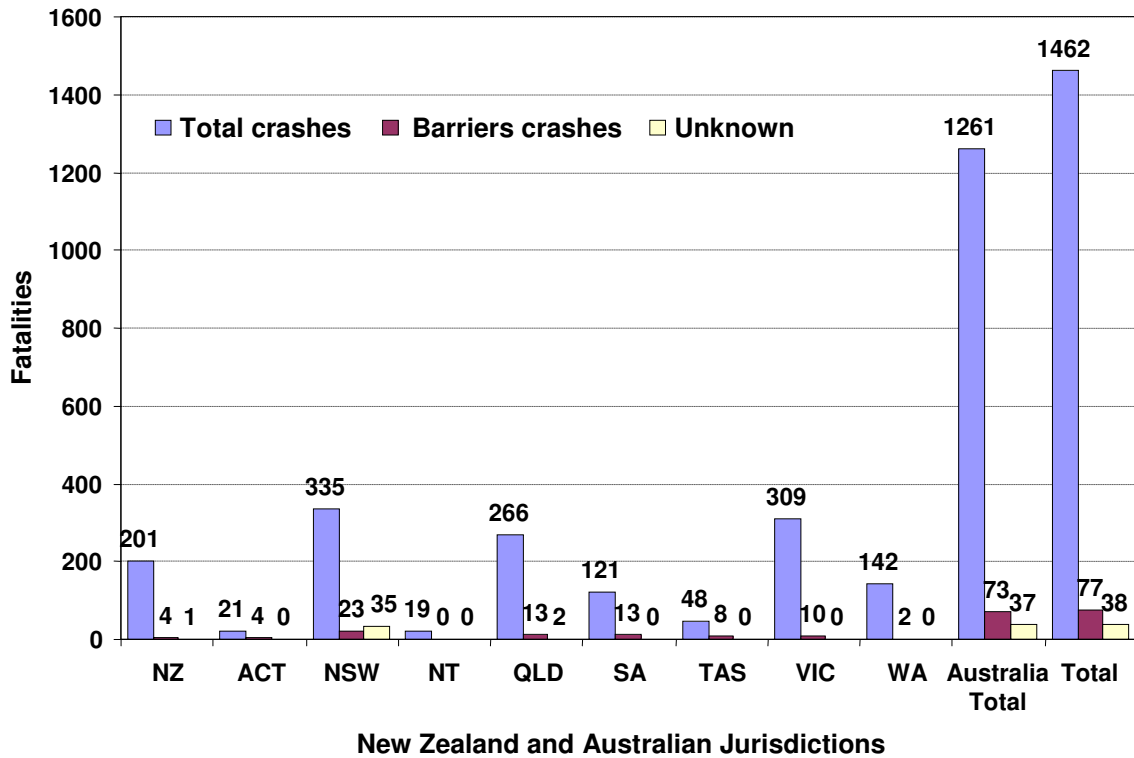
Figure 3: Fatal motorcycle crashes in Australian jurisdictions and New Zealand (2001 to 2006)

The percentage of motorcycle roadside fatalities for NSW that involved a barrier impact is similar to the percentage (8%) reported by Gibson and Benatatos (2000) for 1998/1999. However, the current data reveal some variation between the various states in Australia (Table 4). The Australian Capital Territory (ACT) and Tasmania registered the highest percentages of motorcyclist fatalities involving impacting a roadside safety barrier. This may be a reflection of the low number of motorcycle fatalities being recorded in these jurisdictions. However, the Northern Territory had a similar number of cases to the ACT but recorded zero motorcycle fatalities involving a roadside barrier. This suggests that variations in exposure to roadside safety barriers are probably a factor in the jurisdictional variation in cases.

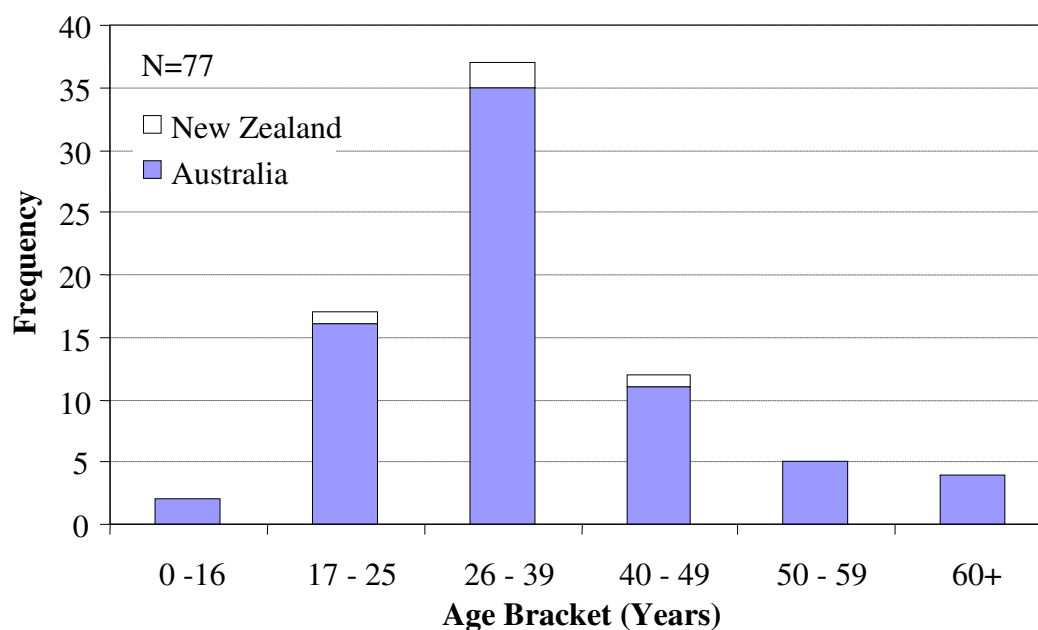
Figure 4: Age distribution of motorcyclist fatalities involving a roadside safety barrier in Australia and New Zealand (2001 to 2006)

Figure 4 shows the breakdown into age groups of motorcyclist fatalities involving a roadside safety barrier in Australia and New Zealand. The youngest and oldest persons killed were 11 and 70 years old respectively. The mean age was 34.2 years and the median was 31 years and 72.3% are aged less than 40 years. The largest group of motorcyclists killed as a result of a collision with a roadside barrier are aged between 26 and 39 years (48.4%). The 17 to 25 years age group was second highest consisting of 22.1%. The fact that riders in the 26 to 39 years age bracket are involved in the majority of the fatalities may be related to their crash risk and possible lack of experience (Harrison & Christie, 2005) but it also may be a reflection of the distribution of the motorcycle riding population. Unfortunately the national age distribution of the Australian motorcycling population was not available.

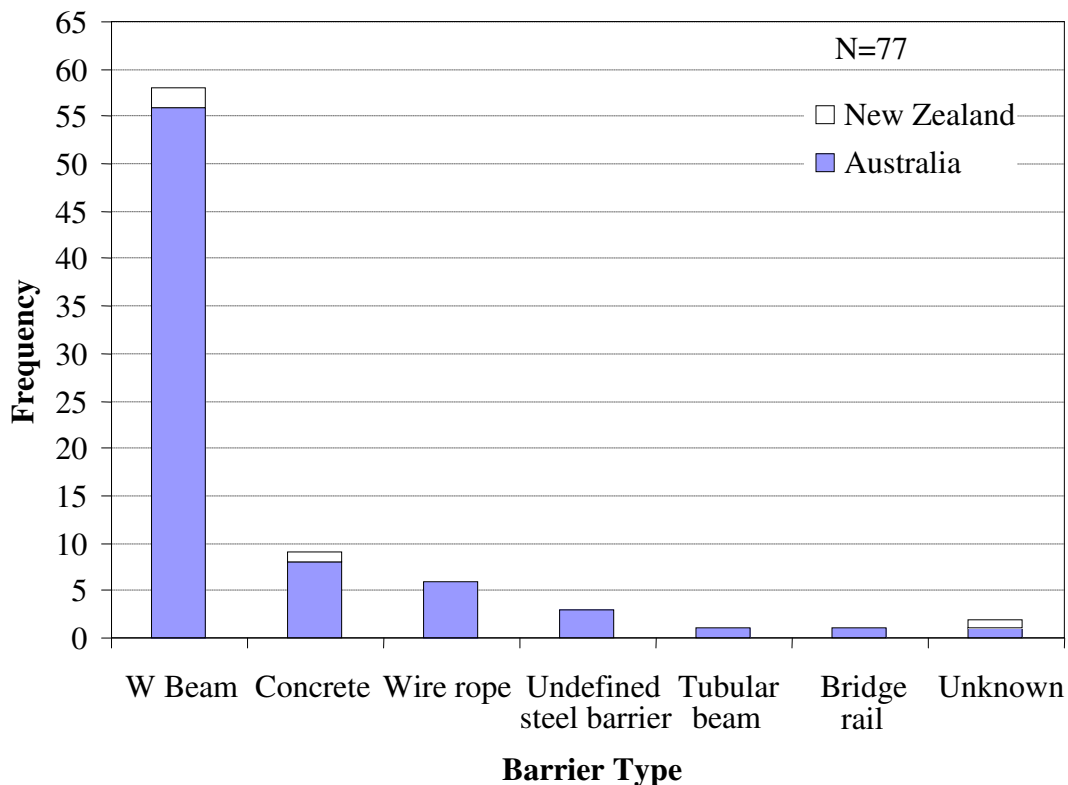
Figure 5: Roadside barrier types involved in motorcyclist fatalities in Australia and New Zealand (2000 to 2006)

Figure 5 shows that fatalities of motorcyclists involving impact with a roadside barrier predominantly involve W beams (72.7%). This was followed by concrete and wire rope barriers that accounted for 10.4% and 7.8% respectively. An additional 3.9% of impacts involved steel barriers, but there was insufficient information available to determine whether these barriers refer to W beams, Tubular or Thrie Beam steel barriers. These fatality proportions may be compared to the proportions of barriers installed (Table 3), which shows that: W beam comprises 71.5% of the barriers and results in 72.7% of the fatalities; concrete comprises 8.6% of the barriers and results in 10.4% of the fatalities; and wire rope comprises 15.9% of the barriers and results in 7.8% of the fatalities. Therefore assuming the probability of a fatality occurring across the network of barriers is similar, wire rope barriers have around half the fatality rate of W beam barriers.

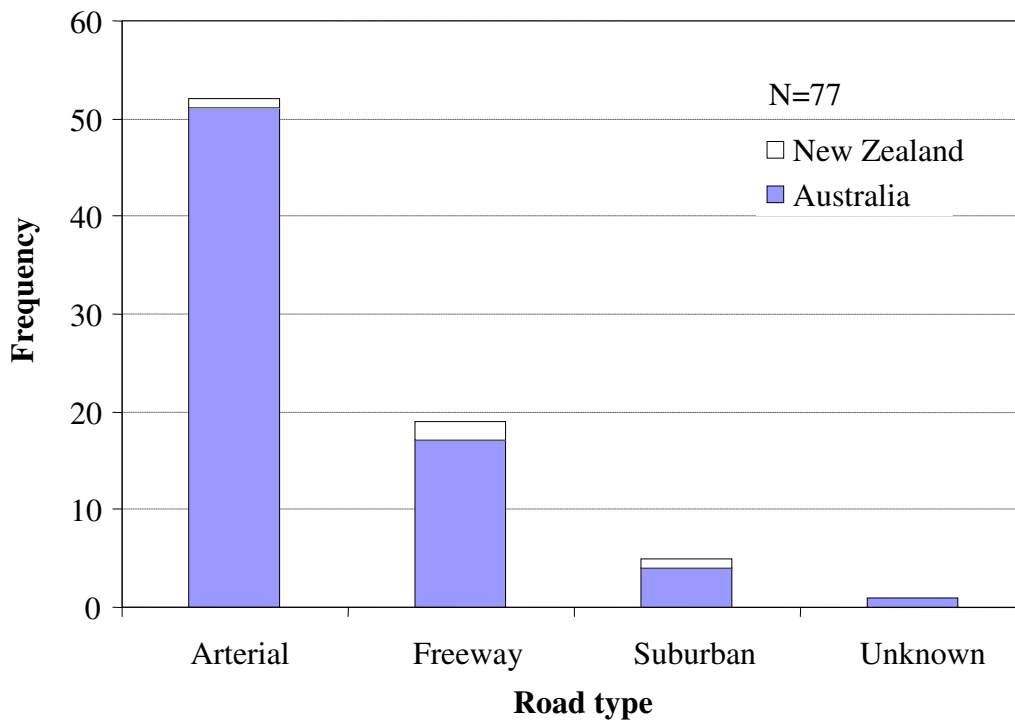
Figure 7: Road type in barrier impact resulting in a motorcyclist fatality in Australia and New Zealand (2001 to 2006)

Fatalities involving a motorcycle impacting a roadside safety barrier mostly occurred on roads with speed limits above 60 km/h. This is consistent with the findings of Gibson and Benatatos (2000). Figure 7 shows that the majority of the crashes occurred on arterial roads. Arterial roads were categorised as roads with speed limits ranging from 60km/h to 100km/h which consist of one or more lanes of traffic travelling in each direction with junctions. This distinguished them from freeways. Arterials accounted for 69.8% of the fatalities. Freeways with speed limits of between 100 and 110km/h accounted for 23.3% of cases. Freeways were categorised as roads which have 2 or more lanes travelling in the same direction with the traffic travelling in the opposite direction separated by a median barrier and no junctions but instead with exit ramps. Suburban roads with speed limits of between 50 and 60km/h accounted for only 5.5% of the fatalities.

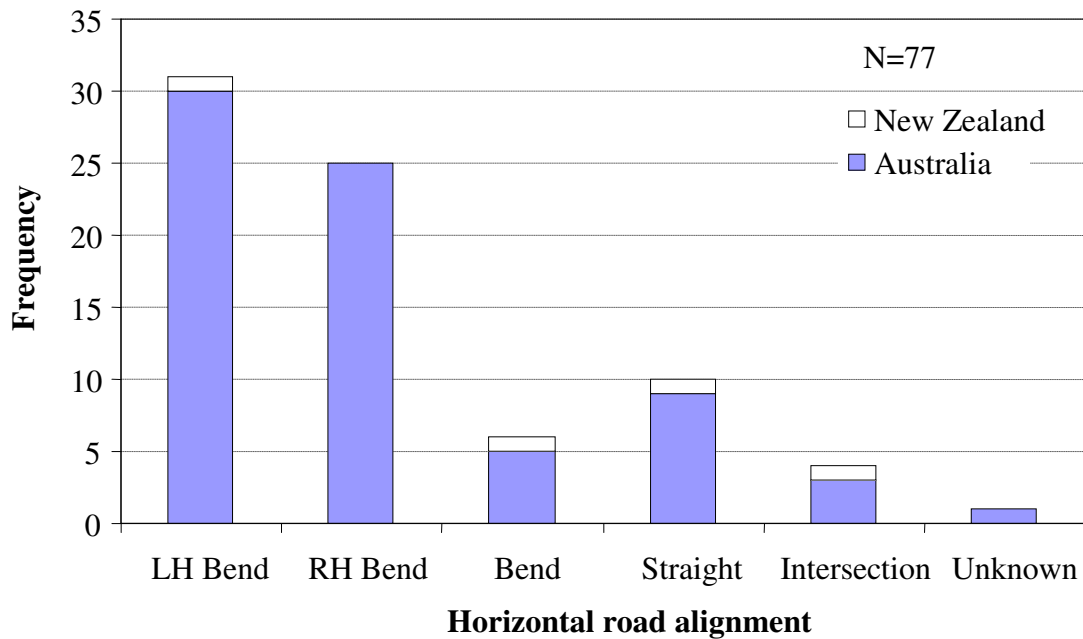
Figure 8: Horizontal alignment of roadside barrier impacted resulting in a fatality in Australian jurisdictions and New Zealand (2001 to 2006)

Figure 8 shows the horizontal alignment of the road site where a motorcyclist died and where an impact into a roadside barrier was involved. 80.8% of fatal crash sites involved a bend in the horizontal alignment of the road. Nearly an equal number of cases involved a left hand and right hand bend with 28 and 26 cases involved respectively. A further 8 cases were described only as a bend. Unfortunately, there was insufficient information in the records to determine the radius of the curvature of the bends involved. Only 14.1% of cases occurred on a straight section of the road and 3.8% occurred at an intersection.

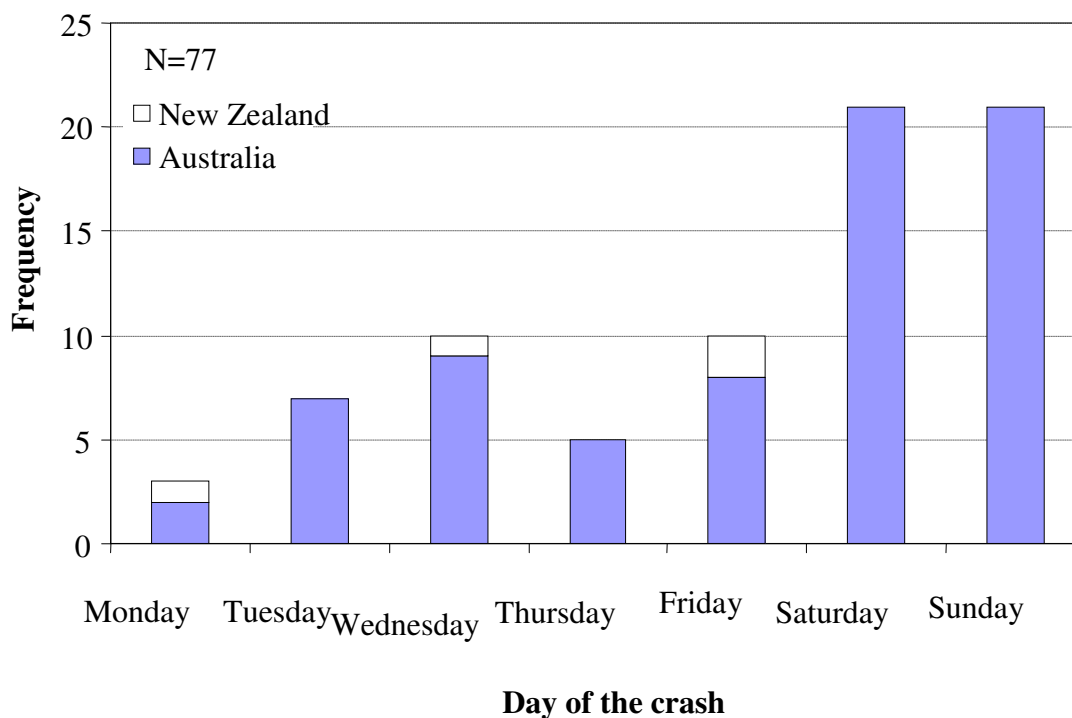
Figure 9: Day of the crash of motorcyclist fatalities involving impact into a roadside safety barrier in Australia and New Zealand (2001 to 2006)

Figure 9 shows that 54% of motorcycle fatalities involving a roadside safety barrier occurred on a weekend, with 21 fatalities associated with each day. The rest of the week witnessed 35 fatalities with an average of 7 deaths for each day. In 46 cases motorcyclists were on a recreational ride, which explains the high frequency of fatalities on a weekend. Driving as a recreational activity is generally known to be a predictor of crashes (Clarke, Ward, Bartle & Truman, 2006; Gregersen & Berg, 1994).

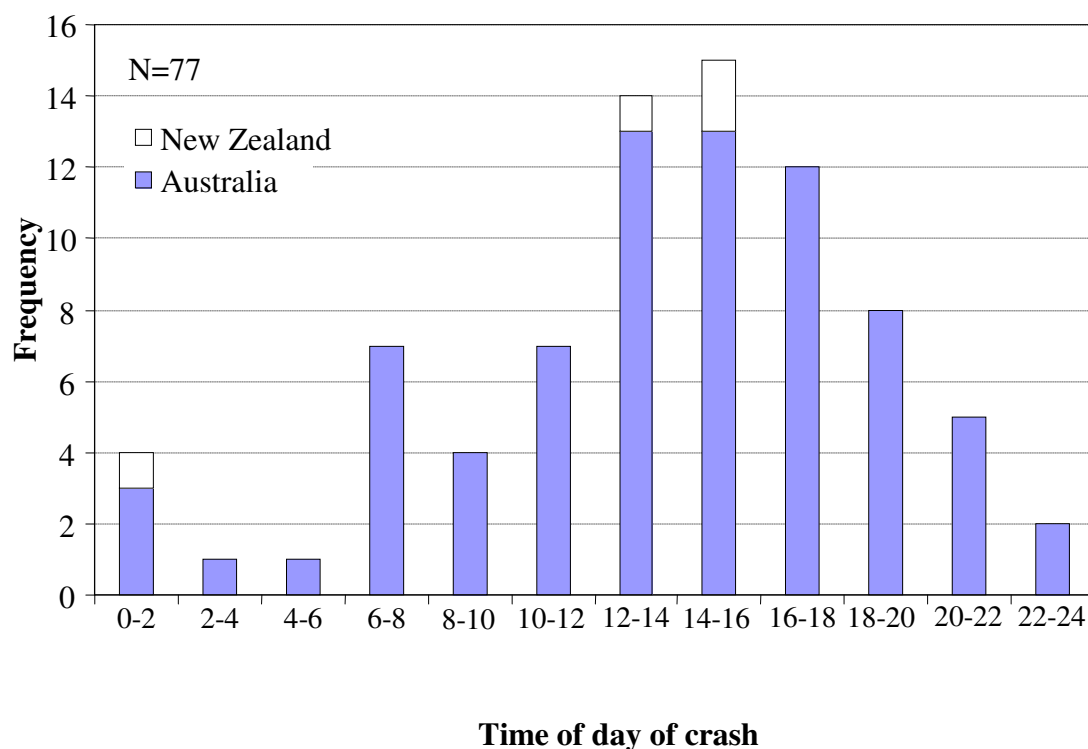
Figure 10: Time of Crash of motorcyclist fatalities involving impact into a roadside safety barrier in Australia and New Zealand (2001 to 2006)

Figure 10 shows that barrier crashes primarily occurred during daylight hours, particularly in the afternoon. This pattern probably reflects exposure, with riders more likely to engage in recreational riding in the afternoon, but it may also be related to fatigue as the recreational riders are likely to be returning from a ride later in the day and may be tired.

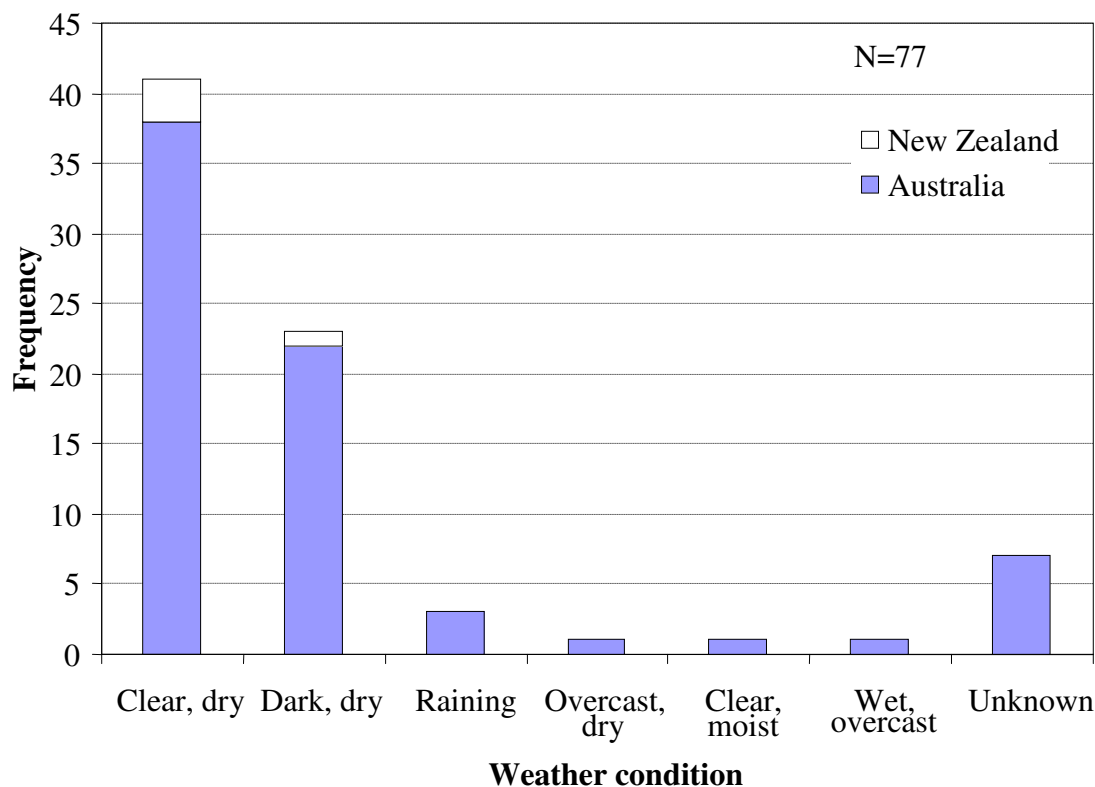
Figure 11: Weather condition at the time of a crash involving a motorcyclist fatality and a roadside safety barrier in Australia and New Zealand (2001 to 2006)

In nearly half of the cases, the weather was described as “clear and dry” or “fine day” and the road surface condition was dry (Figure 11). This was followed by dark conditions with dry road surface in which 28.2% of the fatalities occurred. In 16.7% the description of the weather was insufficient. These results are not surprising as dry conditions are conducive to riding a motorcycle. The authors suspect that the lower numbers for wet conditions reflect exposure, i.e. riders chose not to ride in wet or rainy conditions.

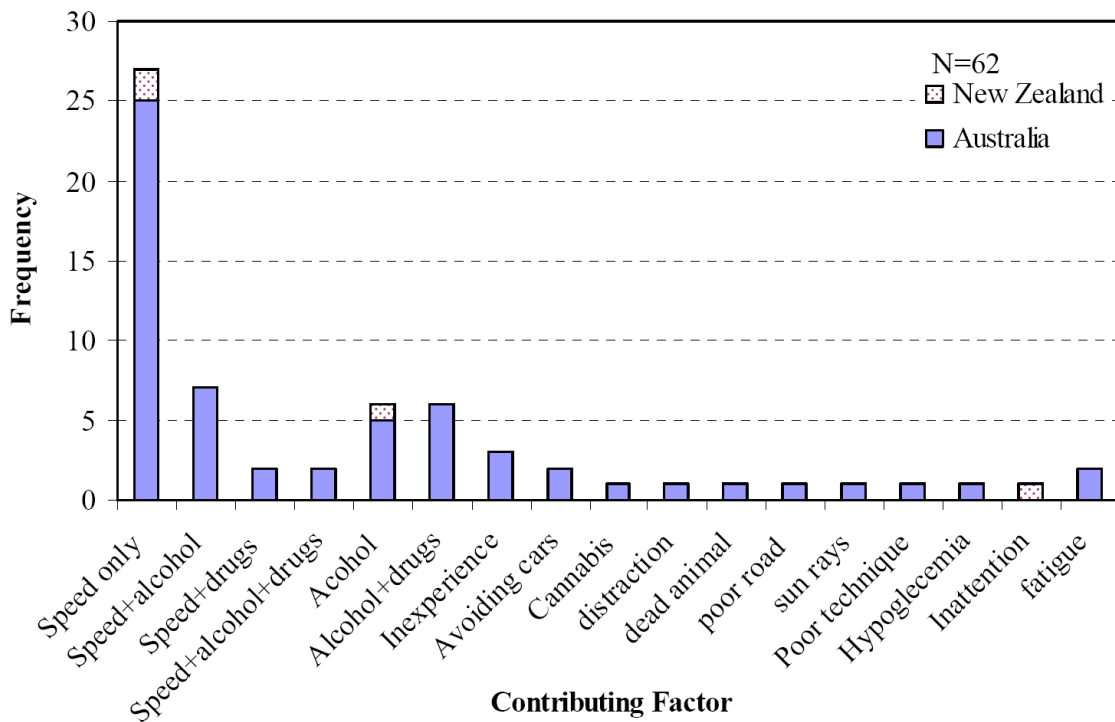
Figure 12: Crash contributory factors of motorcyclist fatalities involving a roadside safety barrier in Australia and New Zealand (2001 to 2006)

A summary of the main factors that contributed to the crash were isolated from the police reports (Figure 12). Speeding or inappropriate speed was found to be the highest single factor

that contributed to the crash (27 cases). Alcohol by itself, closely followed by alcohol with a combination of speed (7) and drugs (6) was also a common contributory factor. Other factors such as avoidance of vehicles and fatigue did not feature highly as contributory factors.
